TOUGHENED (TEMPERED) GLASS

WHY DOES TOUGHENED GLASS SOMETIMES EXPLODE?

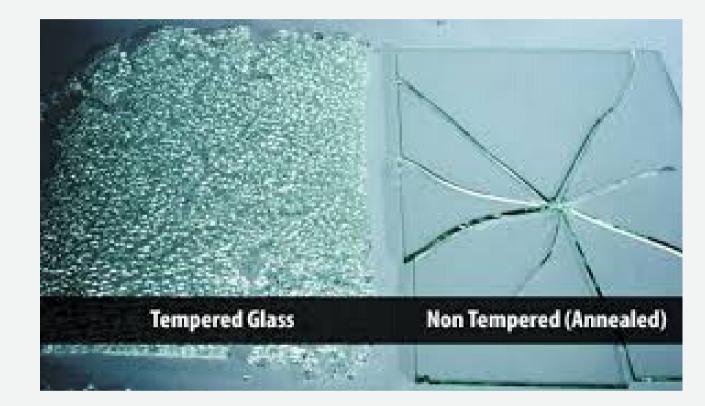
• If float glass is broken, regardless of its thickness it fractures into sharp, jagged pieces which can be very dangerous when broken.

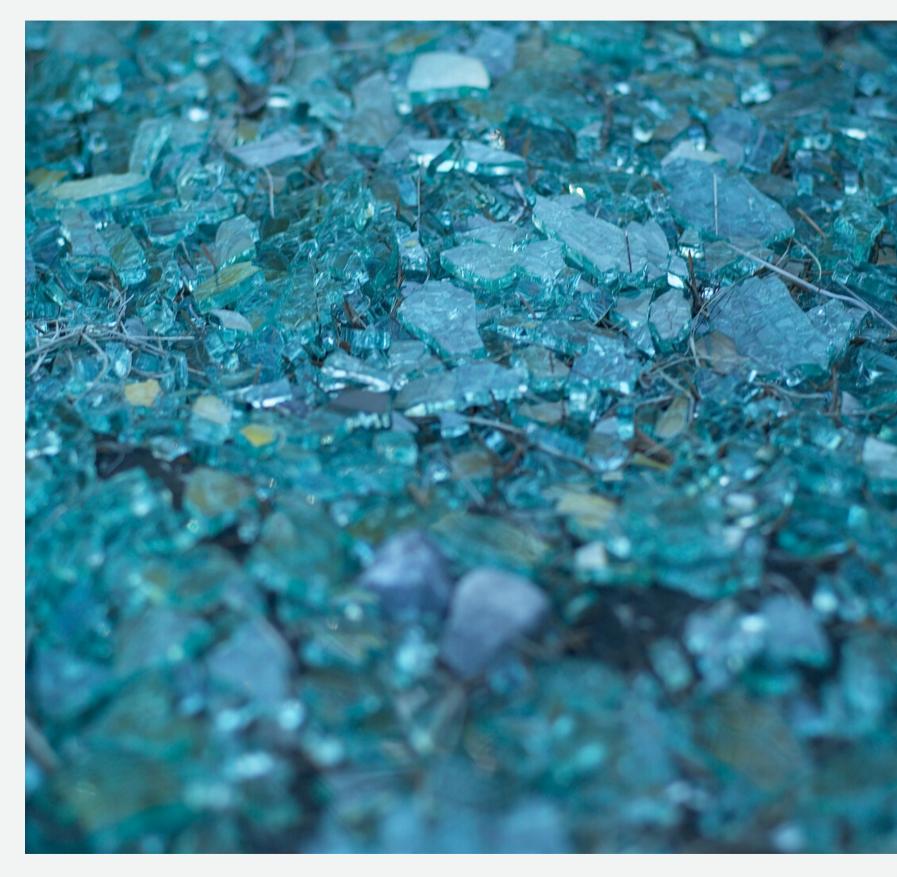
NICKEL SULPHIDE INCLUSIONS

Nickel Sulphide Inclusion is a naturally occurring phenomenon in glass.

Sodium sulphate is added during float glass manufacture to promote bubble removal from the molten glass during the melting process. When combined with a nickel contamination, sodium sulphate forms nickel sulphide (NiS).

During thermal toughening, these inclusions undergo a crystalline phase change to a smaller form and are fixed in place within the glass upon cooling. Over time the inclusions grow and can eventually impart enough stress in the glass to cause spontaneous failure.

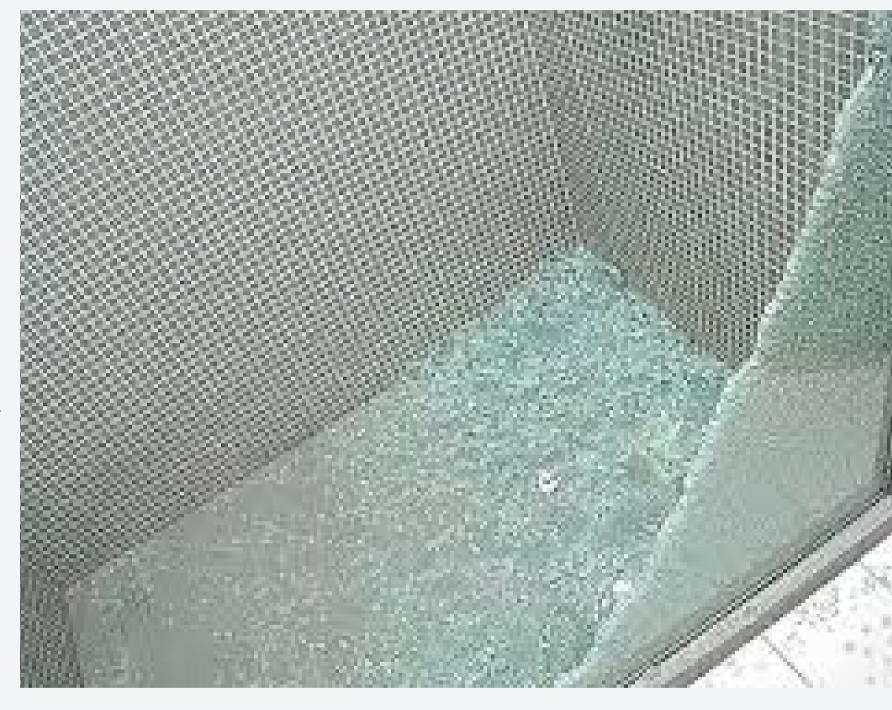
DID NICKEL SULPHIDE INCLUSION CAUSE MY BREAKAGE?

One way to determine whether a glass breakage has been caused by Nickel Sulphide Inclusion is for a trained professional to look for the 'Butterfly Effect' pattern on the glass. The implosion will centre around a singular point on the glass and will fan out in a butterfly wing formation. However, it can be difficult near impossible as generally the glass has fallen to the ground upon the event.

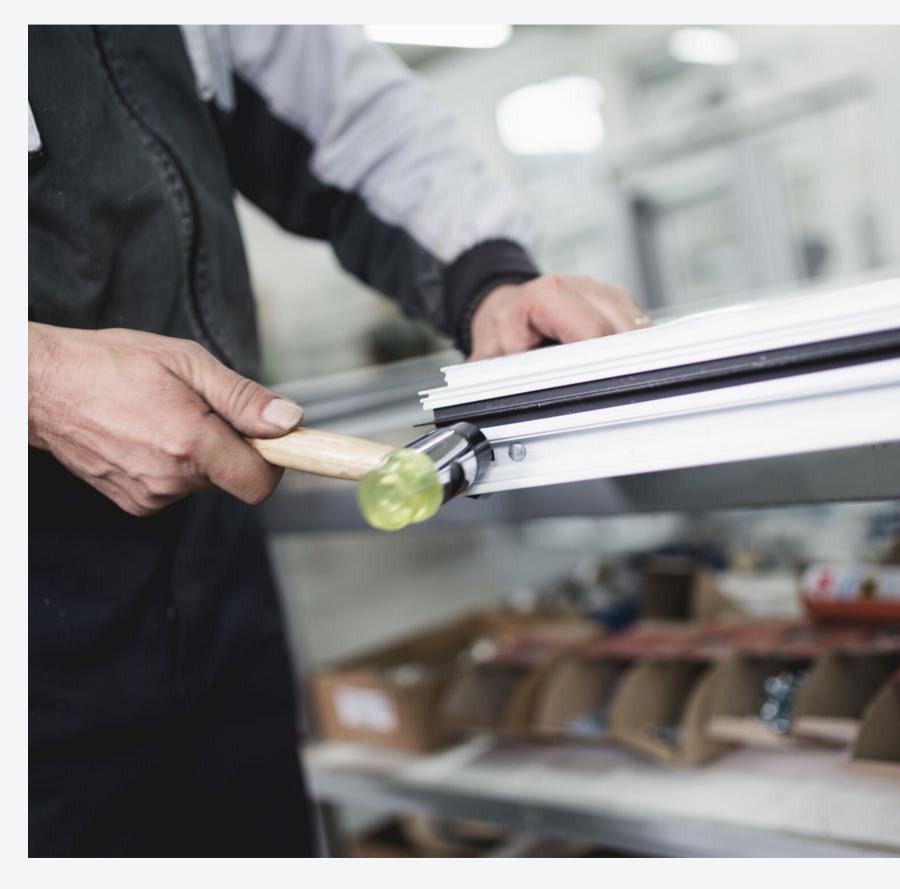
THERMAL STRESSES

When the center of a pane of glass becomes hotter than its edge, expansion of the heated glass center can create tensile stress around the edge.

If the thermal stress exceeds the edge strength, the glass can break.

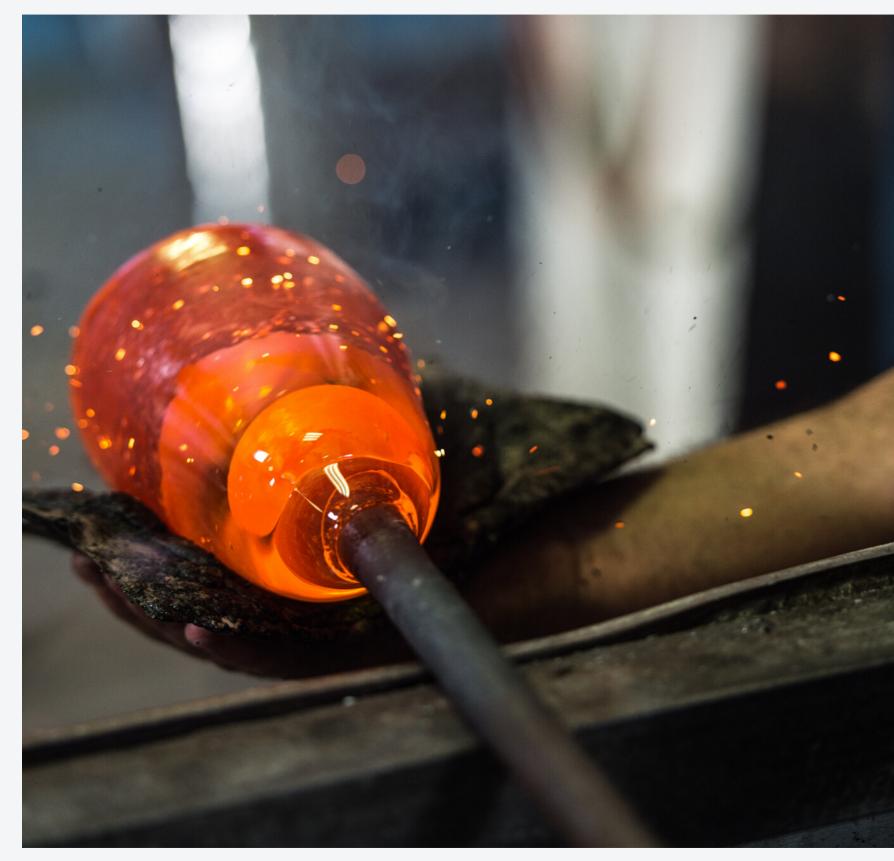
DIRECT IMPACT

While glass once toughen has greater tensile strength properties than float glass, it is however not as strong towards the outer edges of the toughen glass panel as it is in the centre of the panel. Any hard direct impacts may result in the toughened **Grade A Safety Glass** spontaneous exploding into small blunt non-obtrusive particles.

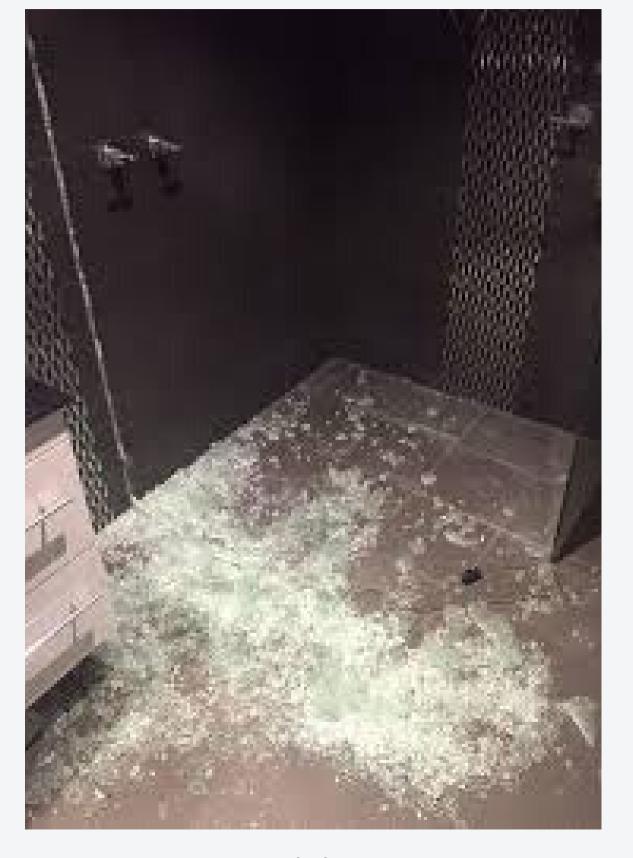
HEAT SOAKED GLASS

The heat soak test is based on reheating the toughened glass to an elevated temperature that accelerates the expansion in the nickel sulphide inclusions. This increases the probability that, if inclusions exist in the glass, the glass will break in the heat soak test rather than insitu. The heat soak process reduces the risk of the spontaneous breakage due to Nickel Sulphide inclusions but it does not guarantee the elimination of Nickel Sulphide impurities.
